Performance of marine and offshore paint systems: correlation of accelerated corrosion tests and field exposure on operating ships

*Nathalie LEBOZEC, Dominique THIERRY, French Corrosion Institute, Brest, France
Philippe LE CALVE, Christian FAVENNEC, DCNS, Lorient, France
Jean-Pierre PAUTASSO, Cédric HUBERT, Délégation Générale de l'Armement,
Bagneux, France*

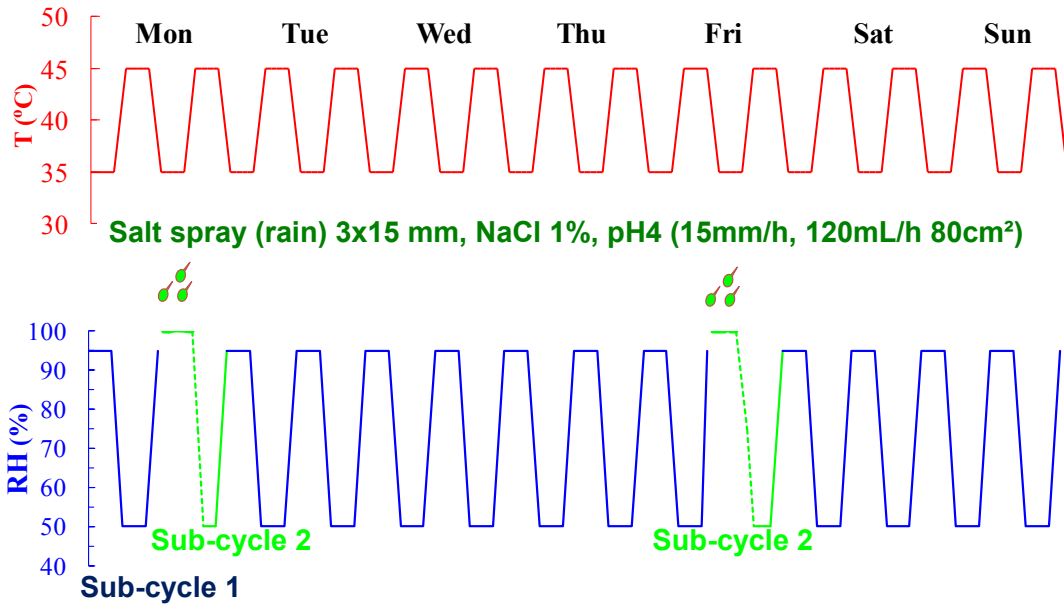
Finally, a cyclic corrosion test ISO 16701 recommended to simulate marine atmospheric conditions was also performed in a dedicated chamber for a total duration of 6 months. The test cycle is presented in Figure 1. It consists of wet and dry cycles conducted at 35°C/95%RH and 45°C/50%RH that alternate with salt rain (NaCl 1wt%, pH 4) applied twice a week.

Figure 1: Description of ISO 16701 test

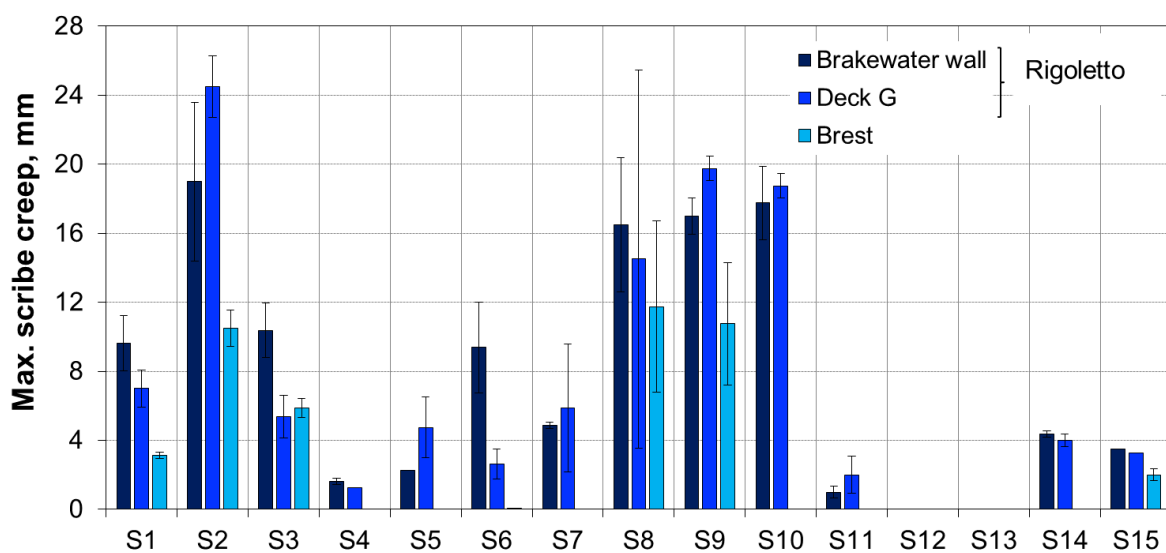
Figure 7: Maximum scribe creep on coated steel after 2 years of exposure on the Rigoletto vessel and at static Brest marine field site. (Max. Delamination – scribe width)/2.

As indicated in the experimental section, all painted specimens were also exposed on a container carrier as well as on a marine site. The exposure on the operating ship was clearly more aggressive than those of the stationary marine site as indicated in Table 7 which presents the metal loss measured on steel and zinc since the start of the exposure in 2010. On the breakwater wall, more than 200 μm of steel loss was indeed measured corresponding to Cx corrosivity class according to ISO 9223. This important aggressiveness on the operating containers carrier induced obviously significant corrosion from the scribe on the coated materials after 24 months of field exposure materials as it is shown in Figure 7. However, no defects on the overall surface e.g. no rusting or blistering was observed neither on the operating ship nor on the stationary site. No major differences between the two locations on the container vessel were observed unless for a couple of systems. The results indicated the good performance of paint systems involving zinc primers e.g. systems S4, S11, S12 and S13, while the poorest performance was observed on some systems with a barrier protection, particularly systems S2, S8, S9 and S10. Intermediate behaviour was noticed on paint systems with inhibitors S14 and S15. Whereas less degradation was observed after the exposure on the static marine site, it may be underlined that the poorest systems were rather similar. It is obvious that the kinetics of degradation were slower at the stationary site compared to the ship as expected from its operating conditions e.g. regular commercial routes to Asia and globally higher temperature, see Table 5.

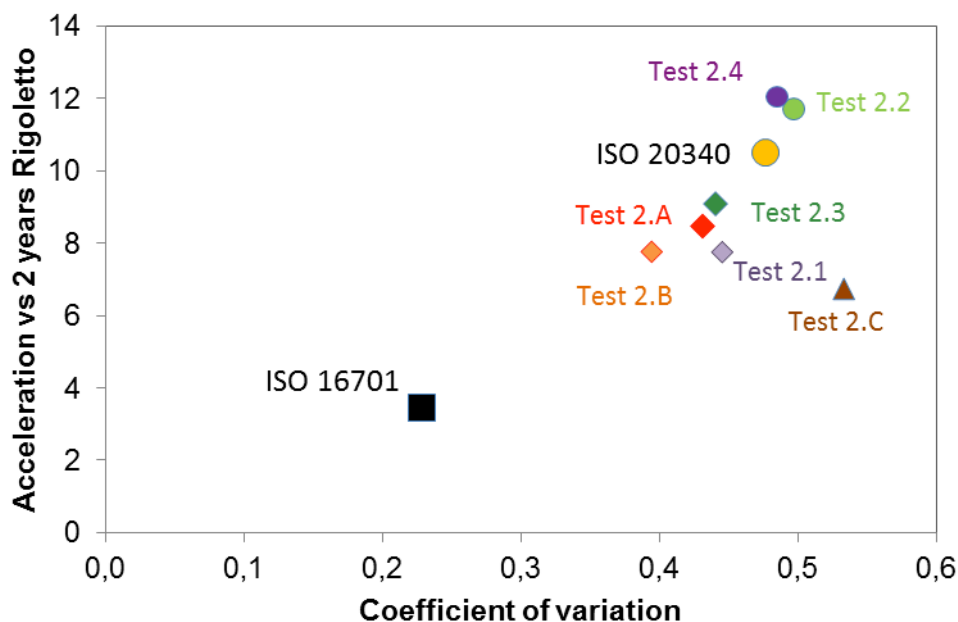
also be considered. This value has obviously a tendency to increase as the mean value of the acceleration increases which makes a comparison of tests difficult. Thus, the relative variation or coefficient of variation which corresponds to the standard deviation divided by the mean acceleration was calculated for each test. Thus, tests with the lowest coefficient of variation would be the tests that accelerate all systems equally. These acceleration factors are plotted in Figure 8 as a function of the coefficient of variation for the different accelerated tests unless the neutral salt spray test that gives unrealistic results (see Figure 2). It should be mentioned that the poor reliability of neutral salt spray test has also been shown by LeBozec *et al.* when considering painted steel and galvanized steel for automotive applications [10]. From Figure 8, it is clear that ISO 16701 test would be the best candidate to simulate field exposure on operating ship such as on the Rigoletto vessel for a C5M/Cx corrosivity category. This test showed a coefficient of variation of 25% with an acceleration of 4, which was the lowest among the tests that were performed. It is interesting to note that testing conditions which include a salt spray phase at 5wt% NaCl (ISO 20340, Tests 2.2 and 2.4) offered the highest acceleration (about 12), but with a deviation of 50%. By lowering the concentration of NaCl to 1wt% in tests 2.1, 2.3, 2.A and 2.B, the acceleration factor diminished to approximately 8, in agreement with previous observation. A lower coefficient of variation between 40 and 45% was also measured, test 2.B showing the lowest variation. The figure clearly indicates a trend for increasing the deviation with the acceleration factor. It should be noted that test 2.C which presented a lower acceleration (e.g. 6) showed however the largest deviation (53%). This observation shall be connected to different underfilm corrosion aspect after this test 2.C as noted earlier. This is illustrated on Figure 9 which shows epoxy based coating S2 after both field exposure and accelerated ageing tests. The aspect of degradation from the scribe is indeed very different upon testing conditions: While large and regular blisters were formed after ISO 20340 test, the size of blisters was smaller in test 2.B operating at 1wt NaCl. In field exposures, more filiform aspect may be noticed rather similarly to that observed after the best testing candidate e.g. ISO 16701 test.

Figure 8: Acceleration factor and coefficient of variation for painted steel panels versus 2 years of exposure on Rigoletto containers carrier.

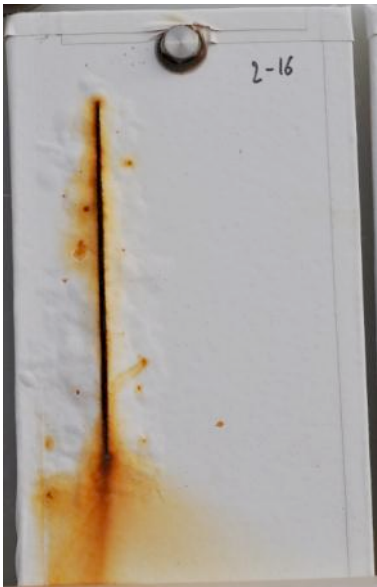
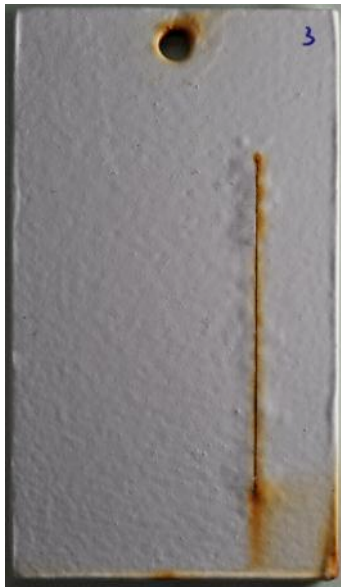
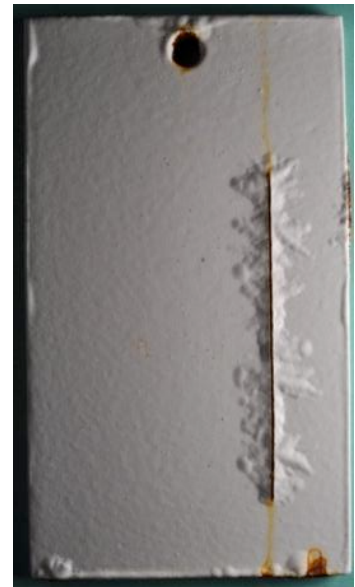
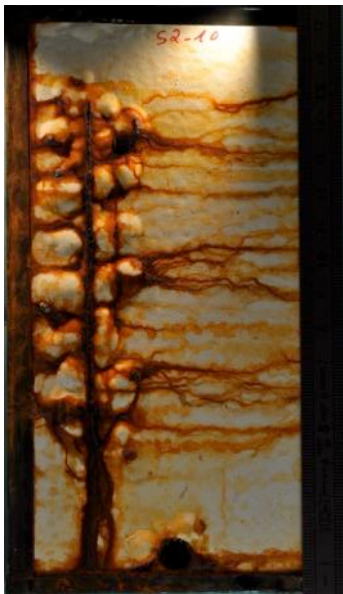
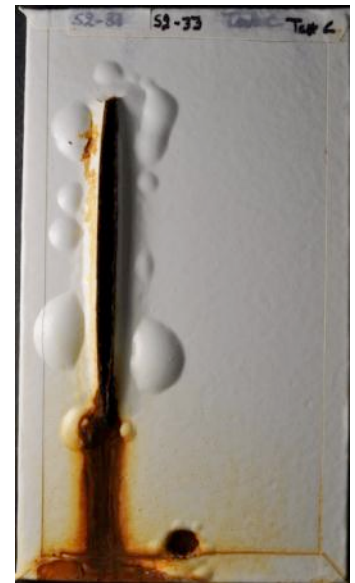
Figure 9: Photographs of epoxy paint system S2 after field exposures and selected accelerated ageing tests (ISO 16701, ISO 20340, Tests 2.B and 2.C).

Another test variant namely test 2.C was finally conducted by replacing the wet and dry cycle at high temperature by an ambient phase, which results are also presented in Figure 3 (bottom) together with the other test variants. In general, less degradation was observed after this test cycle conducted at lower temperature unless for system 2 which was the most affected one. It is well known that temperature affects the kinetics of degradations which would partly explain why it was less important in this test. It should also be noted that the corrosion aspect from the scribe line was different compared to that observed after the other test variants. This may be observed on photographs of Figure 9 for paint system S2.
